CASE STUDY - RESTORATION

MAARTEN DE BEER, GENERAL DENTAL PRACTITIONER

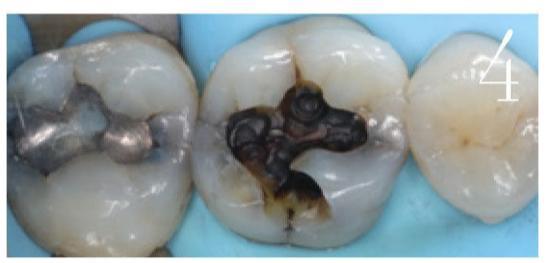
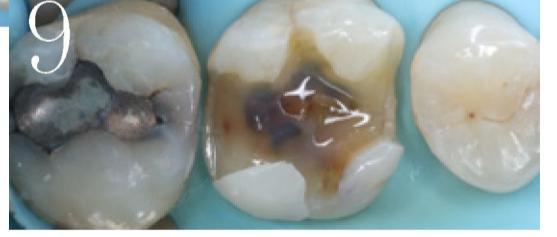
The tooth is sandblasted (AquaCare, velopex), etched (Ultraetch, Ultradent Products) and a primer and bonding agent are applied (Optibond FL, Kerr). A thin layer of flowable composite (Majesty ES A2, Kuraray) is applied to the dentin and the distopalatal cusp is restored (Beautifill II LS A2, Shofu) using the previously prepared putty mold (Fig. 8 and 9).

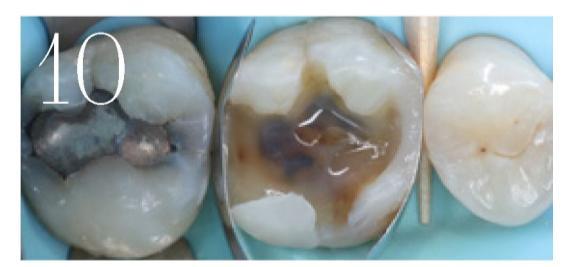
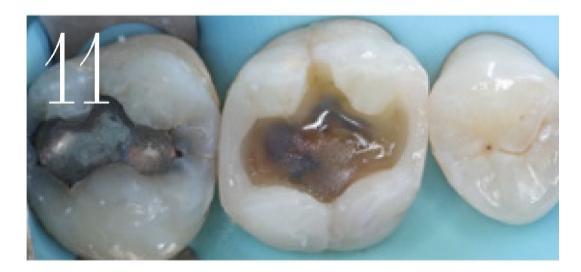
The mesial and distal margins are constructed using partial contact matrices, a wooden wedge, and a separation ring *(Beautifill II LS A2, Shofu) (Fig. 10 and 11).* The tooth is then reconstructed cusp by cusp and the fissure is colored *(Kolor+brown, Kerr). Fig. 12*

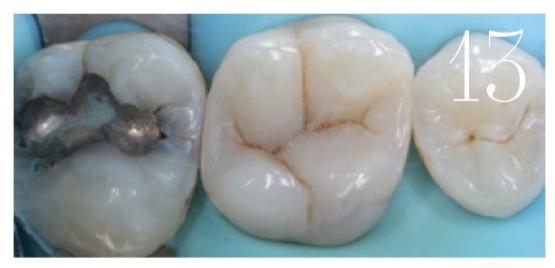
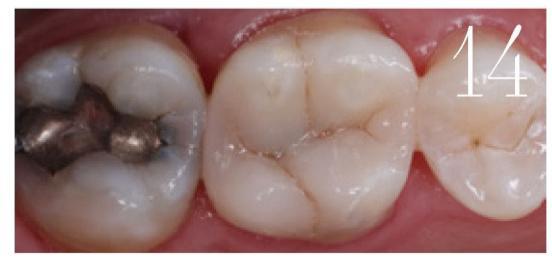
The excess of composite on the cusp tips was removed with a hardened steel burr (*NeoBurrFG TC00EF3*) and the composite was then polished with a diamond-coated polishing wheel (*Diacomp plus twist, Eve*) (*Fig. 13 and 14*).
